**Flood Control Project Maintenance
Levee Inspections**

Fall 2014 Levee Maintenance Deficiency Summary Report

Sutter Maintenance Yard Wadsworth Canal

Levee Inspection Report By Mile - Fall 2014

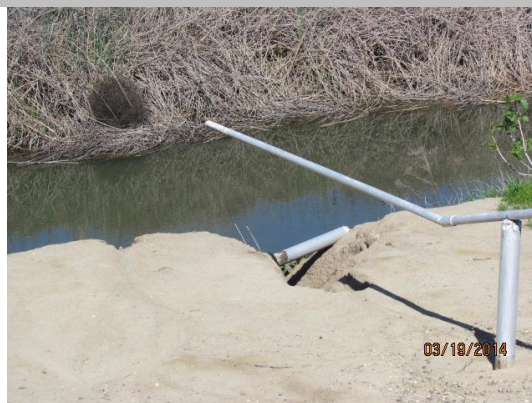
Photo 1 of 1 : FA_2014_ST0010_42_14_20141013_00004.jpg

LM Start	2.40	Rating **	M	Issue No.	14
LM End	2.40	Issue Type +	Ma	Location *	WS
Category	Earthen Levee			GPS Latitude/Longitude	
				Start	End
Item	Erosion / Bank Caving			39.141697 °	39.141697 °
				-121.742819 °	-121.742819 °
DWR ID	DWR_ST0010_01_s_2012_14				
Action/Comments					
Schedule repair of erosion site prior to the next inspection.

View of the erosion along the fence.

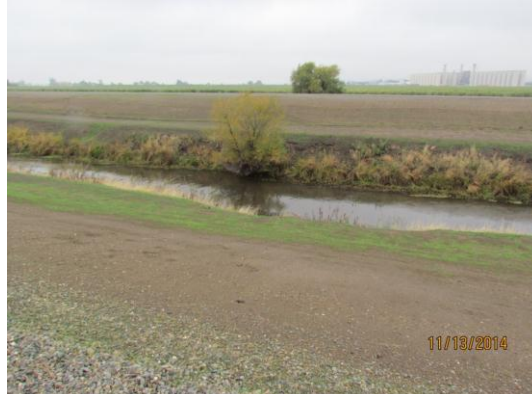
Photo 1 of 1 : FA_2014_ST0010_42_18_20141113_00009.jpg

LM Start	2.61	Rating **	M	Issue No.	18
LM End	2.61	Issue Type +	Ma	Location *	WS
Category	Earthen Levee			GPS Latitude/Longitude	
				Start	End
Item	Erosion / Bank Caving			39.144313 °	39.144313 °
				-121.740758 °	-121.740758 °
DWR ID	DWR_ST0010_01_f_2014_18				
Action/Comments					
Note and monitor erosion site.					
Inspector Comments: The erosion is scheduled for repair in 2015.

View of the erosion along the waterside toe.

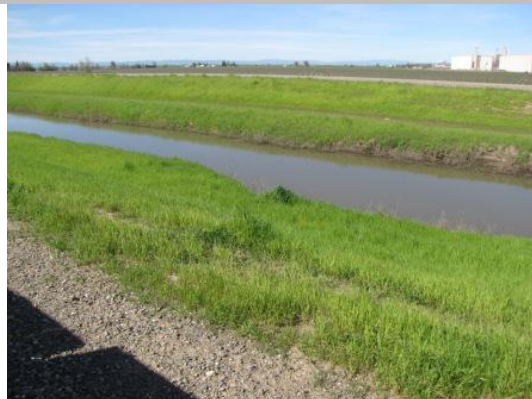
Photo 1 of 1 : FA_2014_ST0010_42_1_20141013_00001.jpg

LM Start	2.76	Rating **	M	Issue No.	1
LM End	2.76	Issue Type +	Ma	Location *	WS
Category	Earthen Levee			GPS Latitude/Longitude	
				Start	End
Item	Erosion / Bank Caving			39.146063 °	39.146063 °
				-121.739288 °	-121.739288 °
DWR ID	DWR_ST0010_01_s_2012_1				
Action/Comments					
Note and monitor erosion site.

View of erosion along W/S toe.

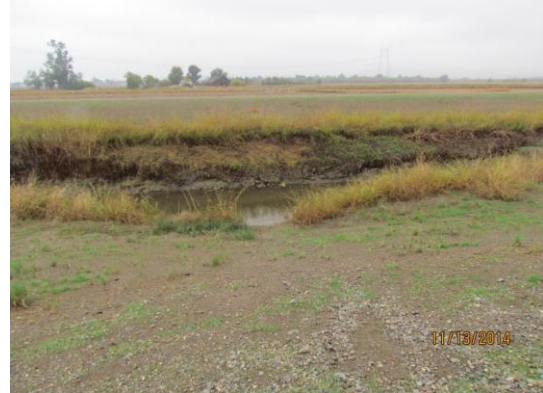
Photo 1 of 1 : FA_2014_ST0010_42_17_20141113_00008.jpg

LM Start	3.87	Rating **	M	Issue No.	17
LM End	3.87	Issue Type +	Ma	Location *	WS
Category	Earthen Levee			GPS Latitude/Longitude	
				Start	End
Item	Erosion / Bank Caving			39.160442 °	39.160442 °
				-121.731067 °	-121.731067 °
DWR ID	DWR_ST0010_01_f_2014_17				
Action/Comments					
Note and monitor erosion site.

View of the erosion along the waterside toe.

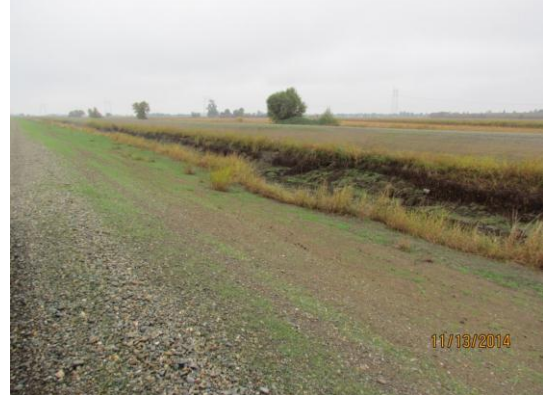
Photo 1 of 1 : FA_2014_ST0010_42_5_20141113_00007.jpg

LM Start	4.27	Rating **	M	Issue No.	5
LM End	4.27	Issue Type +	Ma	Location *	WS
Category	Earthen Levee			GPS Latitude/Longitude	
				Start	End
Item	Erosion / Bank Caving			39.165845 °	39.165845 °
				-121.728877 °	-121.728877 °
DWR ID	DWR_ST0010_01_s_2012_5				
Action/Comments					
Note and monitor erosion site.

View of the erosion along the waterside toe.

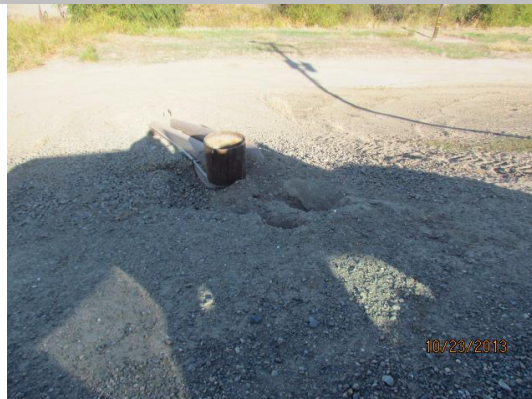
Photo 1 of 1 : FA_2014_ST0010_43_11_20141013_00006.jpg

LM Start	1.77	Rating **	M	Issue No.	11
LM End	1.77	Issue Type +	Ma	Location *	LS
Category	Earthen Levee			GPS Latitude/Longitude	
				Start	End
Item	Animal Control			39.134490 °	39.134490 °
				-121.749716 °	-121.749716 °
DWR ID	DWR_ST0010_02_f_2012_11				
Action/Comments					
No rodents visible, but rodent burrows visible; need to backfill and compact or grout burrows.

View of the rodent holes above the irrigation pipe.

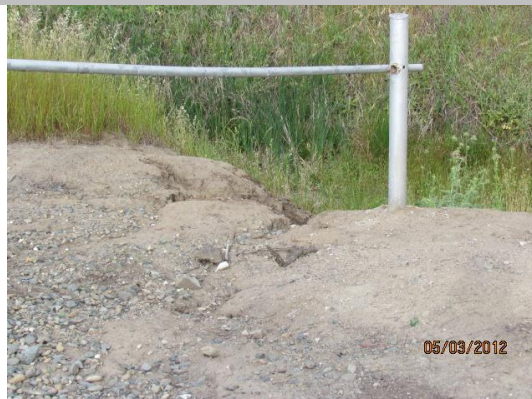
Photo 1 of 1 : FA_2014_ST0010_43_14_20141013_00007.jpg

LM Start	3.30	Rating **	M	Issue No.	14
LM End	3.30	Issue Type +	Ma	Location *	LS
Category	Earthen Levee			GPS Latitude/Longitude	
				Start	End
Item	Erosion / Bank Caving			39.152903 °	39.152903 °
				-121.734906 °	-121.734906 °
DWR ID	DWR_ST0010_02_s_2012_14				
Action/Comments					
Note and monitor erosion site.					
Inspector Comments: The erosion is scheduled for repair in 2015

View of the erosion along the W/S toe.

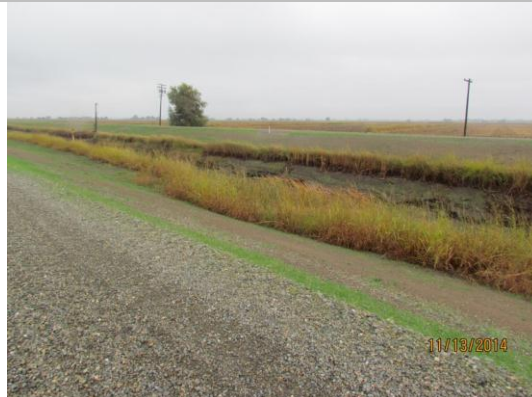
Photo 1 of 1 : FA_2014_ST0010_43_4_20141113_00012.jpg

LM Start	3.46	Rating **	M	Issue No.	4
LM End	3.46	Issue Type +	Ma	Location *	WS
Category	Earthen Levee			GPS Latitude/Longitude	
				Start	End
Item	Erosion / Bank Caving			39.155057 °	39.155057 °
				-121.733985 °	-121.733985 °
DWR ID	DWR_ST0010_02_s_ 2012_4				
Action/Comments					
Note and monitor erosion site.

View of the erosion at the waterside toe.

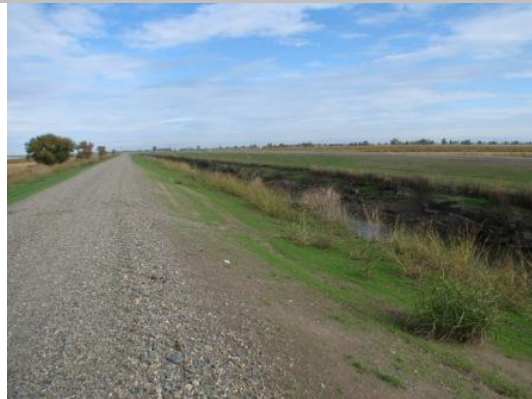
Photo 1 of 1 : FA_2014_ST0010_43_5_20141013_00003.jpg

LM Start	3.59	Rating **	M	Issue No.	5
LM End	3.99	Issue Type +	Ma	Location *	WS
Category	Earthen Levee			GPS Latitude/Longitude	
				Start	End
Item	Erosion / Bank Caving			39.156753 °	39.162113 °
				-121.733267 °	-121.730997 °
DWR ID	DWR_ST0010_02_s_ 2012_5				
Action/Comments					
Note and monitor erosion site.

View of the erosion along the waterside toe.

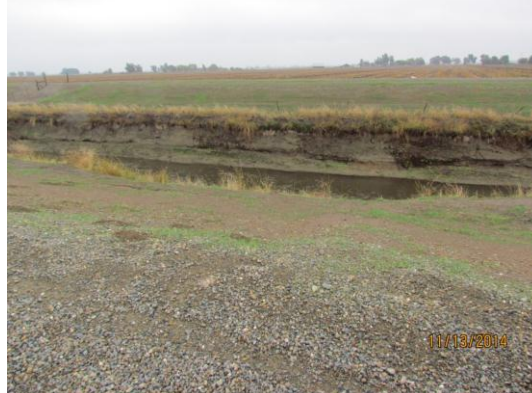
Photo 1 of 1 : FA_2014_ST0010_43_6_20141113_00013.jpg

LM Start	4.49	Rating **	M	Issue No.	6
LM End	4.49	Issue Type +	Ma	Location *	WS
Category	Earthen Levee			GPS Latitude/Longitude	
				Start	End
Item	Erosion / Bank Caving			39.168848 °	39.168848 °
				-121.728130 °	-121.728130 °
DWR ID	DWR_ST0010_02_s_ 2012_6				
Action/Comments					
Note and monitor erosion site.

View of the erosion along the waterside toe.

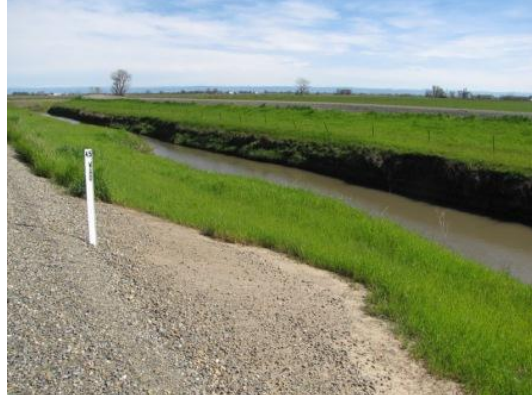
Photo 1 of 1 : FA_2014_ST0010_43_7_20141013_00005.jpg

LM Start	4.55	Rating **	A/W	Issue No.	7
LM End	4.55	Issue Type +	Ma	Location *	WS
Category	Earthen Levee			GPS Latitude/Longitude	
				Start	End
Item	Erosion / Bank Caving			39.169670 °	39.169670 °
				-121.727787 °	-121.727787 °
DWR ID	DWR_ST0010_02_s_ 2012_7				
Action/Comments					
Note and monitor erosion site.

View of the erosion along the W/S toe.
